# Manhole Inspection Summary

Manhole # S49K\_\_034MH

Insp Date: **3/26/08 3:49 PM**

**Location** Address: **741 S Montford Av**

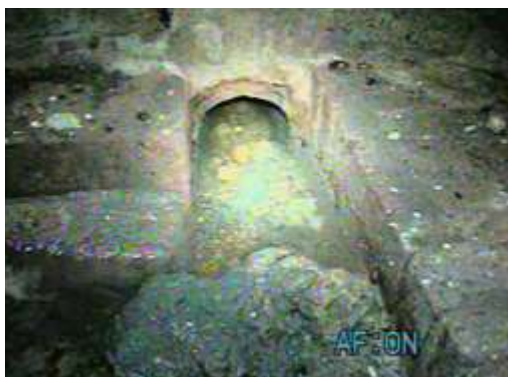
Defect 3

Condition: ☐ Sound ☐ Cracked ☐ Root Intrusion ☐ Deteriorated ☐ Leaks ☒ **Debris**

channel cond debris

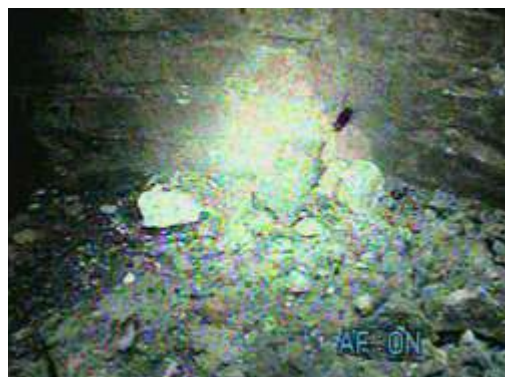
Defect 2

Condition: ☐ Sound ☐ Cracked ☐ Root Intrusion ☐ Deteriorated ☐ Leaks ☒ **Debris**

bench cond debris

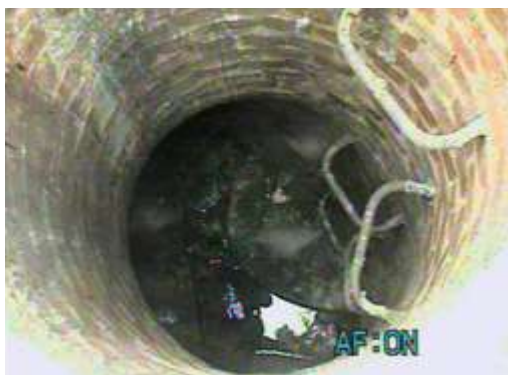
Defect 1

Count: **5** Missing: **0** ☒ **Corroded**

corroded stairs

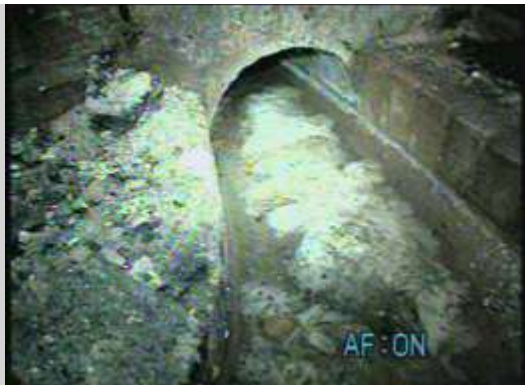
3 O'Clock Inflow

Deposits: ☐ None ☐ Mud ☒ Gravy ☒ Debris ☐ Grease

Silt Depth: 3 (in.) Deposits Extent: **Medium**
